Landslides (2018) 15:199–217  
DOI 10.1007/s10346-017-0865-0

R. Tomás · A. Abellán · M. Cano · A. Riquelme · A. J. Tenza-Abril · F. Baeza-Brotons · J. M. Saval · M. Jaboyedoff

## A multidisciplinary approach for the investigation of a rock spreading on an urban slope

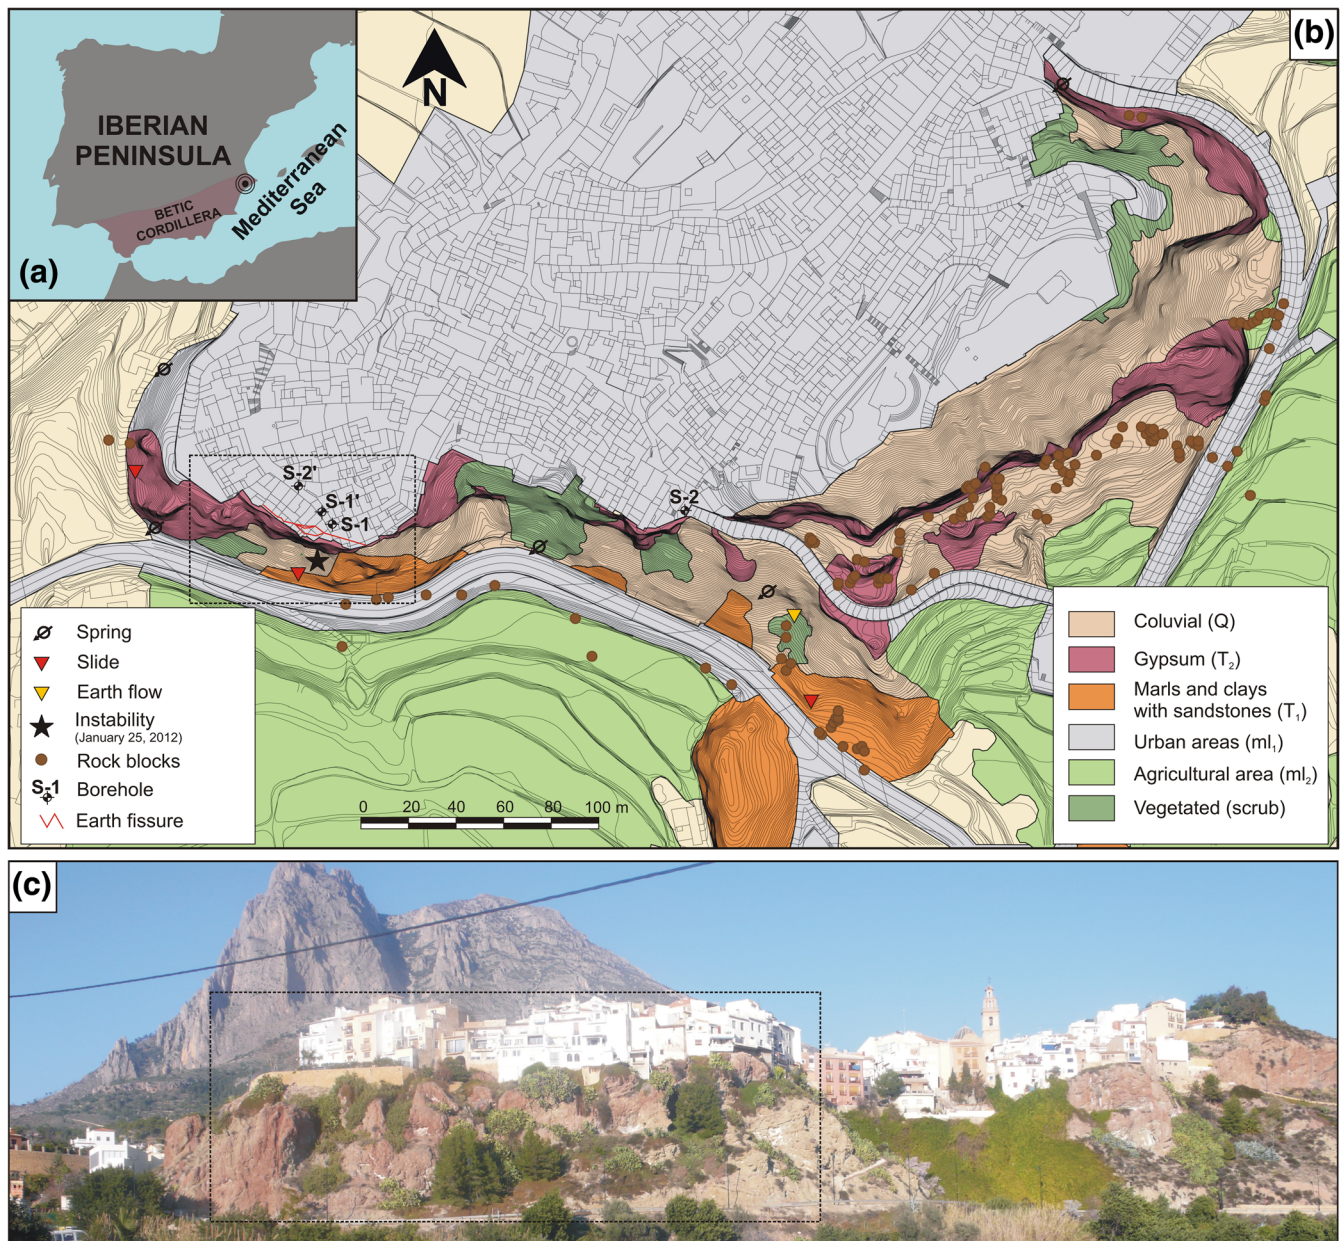
**Fig. 1** a Location and b geology of the study area (modified from Colodrón and Ruiz 1978, Saval et al. 2009). c General view of the study area taken in 2011. The dashed rectangles plotted in (b) and (c) correspond to the sector of the slope studied in this work

slope: an earth flow, small ( $<1 \text{ m}^3$ ) planar slides and numerous rockfalls (according to Cruden and Varnes 1996, Hungr et al. 2014). However, rockfalls are the more common landslide type affecting the upper part of the slope (i.e.  $T_2$  subunit) recognized in the study area. Figure 1 shows the location of the blocks fallen from the main scarps of the slope. The volume of these blocks ranges from 0.1 to  $19.0 \text{ m}^3$  and are mainly composed of massive gypsum (Saval, et al. 2009). As a consequence of activity of the slope, a series of corrective measures were taken by the local authorities to improve its security during the second half of 2015. The developed works mainly consisted of the purge of unstable small rock blocks and the construction of an anchored reinforced concrete capping beam under the buildings located on the crown to improve their structural stability. Complementarily, the slope was draped by a cable net combined with a geotextile that was pinned to the slope using rock bolts.

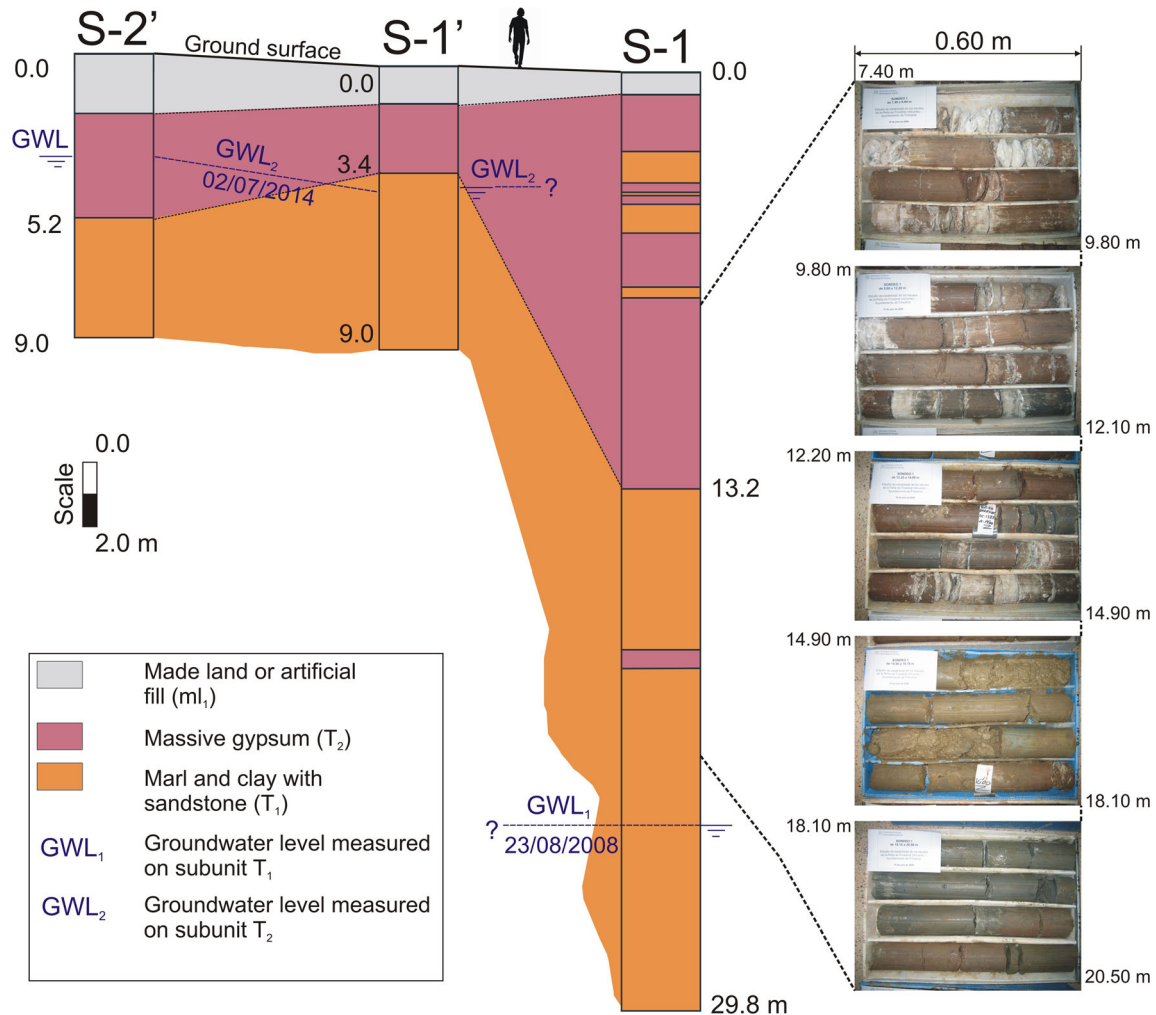
Fig. 2 Geotechnical borehole logs. See the location of the boreholes in Fig. 1

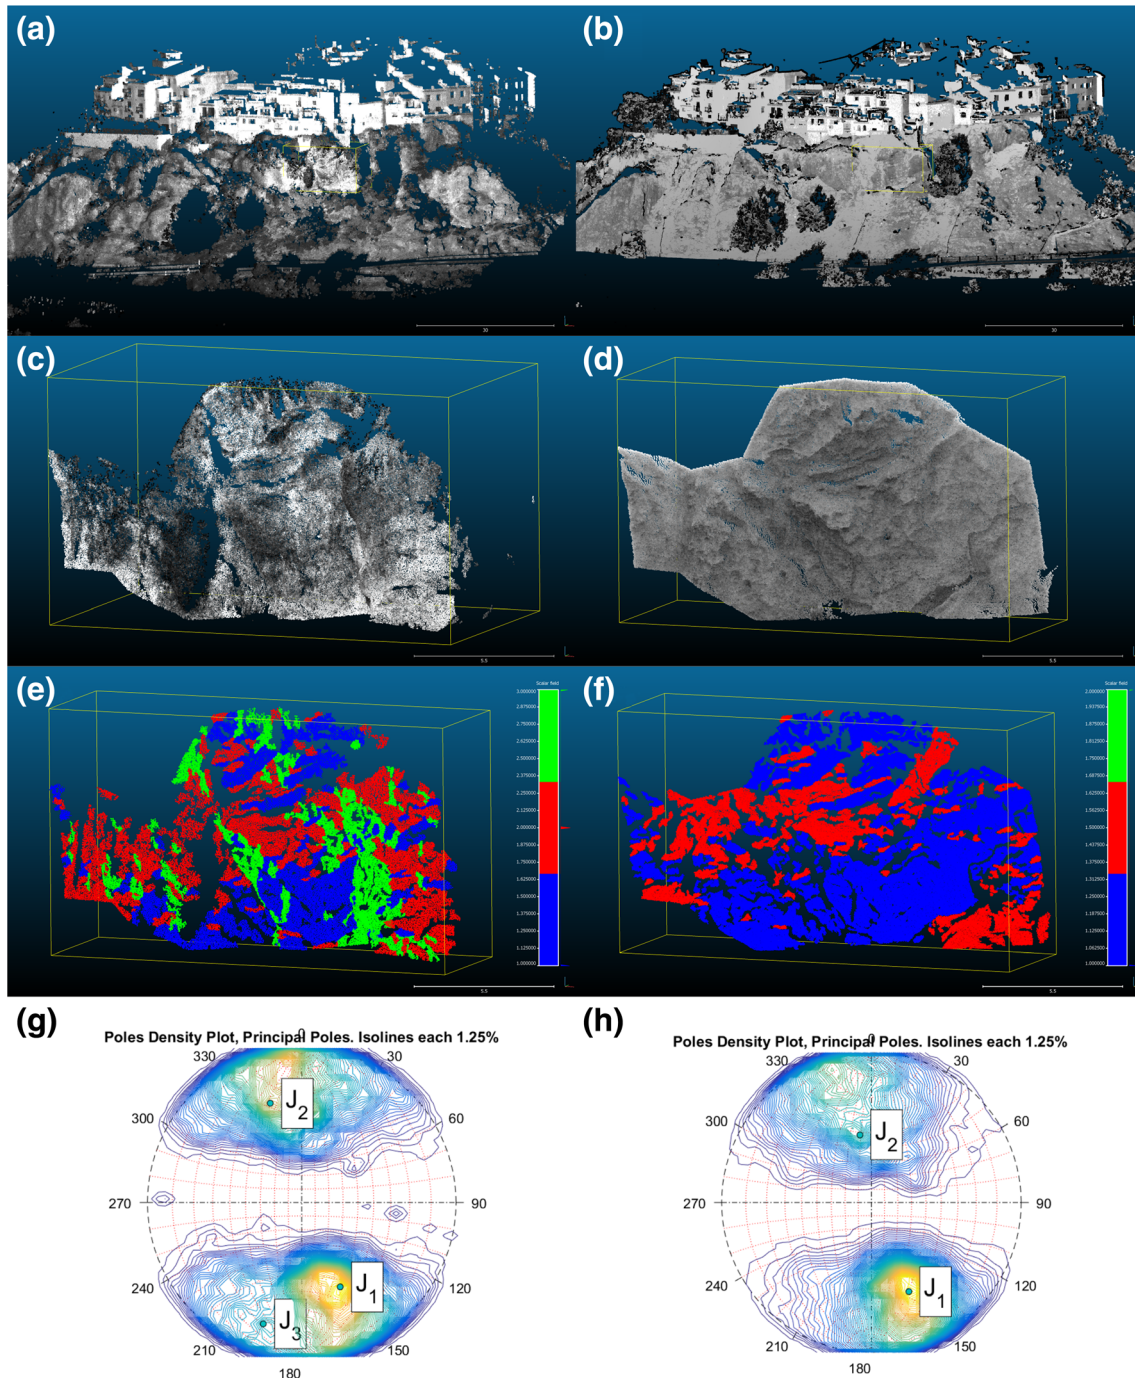
identifies and defines the different planar discontinuities of the rock mass slope surface by applying an analysis based on a neighbouring points coplanarity test, finding principal orientations by the non-parametric technique Kernel Density Estimation (Botev et al. 2010) and identifying clusters by the density-based scan algorithm with noise (Ester et al. 1996). This information has allowed the identification of the most important discontinuity sets affecting the slope from the available 3DPC corresponding to 2011 (i.e. before the largest failure) and 2012 (i.e. after the large failure). The results are shown in Figs. 8 and 9 in which three and two discontinuity sets have been recognized from the 2011 and 2012 3DPCs, respectively, in the gypsiferous massif (i.e. subunit T<sub>1</sub>). The three discontinuities identified from 2011 3DPC present the following orientations: 336/62 for J<sub>1</sub> (blue in Fig. 8e), 162/68 for J<sub>2</sub> (red in Fig. 8e) and 18/79 for J<sub>3</sub> (green in Fig. 8e). The processing of 2012 data only allows recognizing two sets of planar discontinuities: 337/66 for J<sub>1</sub> (blue in Fig. 8f) and 170/49 for J<sub>2</sub> (red in Fig. 8f).

**Fig. 8** 3DPCs obtained from **a** 2011 and **b** 2012 surveys for the whole slope. **c, d** Correspond to the 2011 and 2012 3DPCs, respectively, of the processed areas located on the failure sector. **e, f** Show the identification of the discontinuity sets derived from the 2011 and 2012 LiDAR surveys. Note that each *colour* correspond to a different discontinuity set. **g, h** The normal vector density plot for 2011 and 2012 3DPC, respectively. See a picture with the location of the discontinuity sets on Fig. 9a

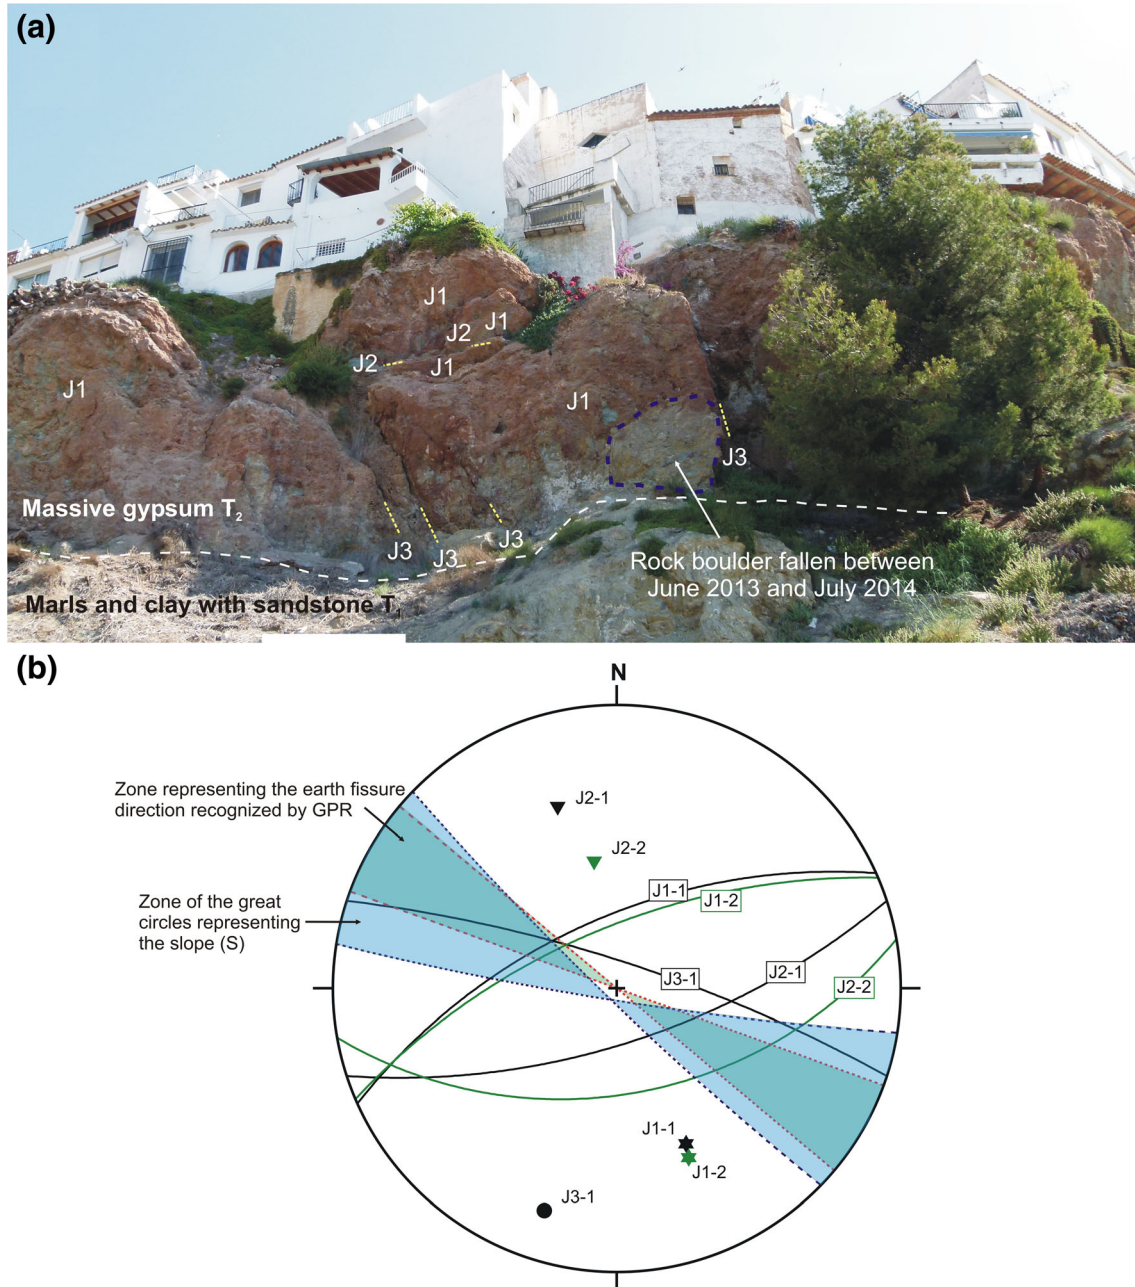
Figure 9b represents the stereographic projection of the different discontinuity sets derived from the analysed 3DPCs (J<sub>1</sub>, J<sub>2</sub> and J<sub>3</sub>) as well as the zone of the great circles representing the variability of the slope (S) direction. The zone representing the range of directions of the earth fissure recognized by means of the GPR technique is also represented in the plot. From the figure, it is clear that J<sub>1</sub> (the most exposed discontinuity) and J<sub>3</sub> present a similar subvertical dip value and dip into the slope being geometrically compatible with a toppling failure mode. On the other hand, discontinuity set J<sub>2</sub> dips out of the slope with a variable dip between 49 and 68° being prone to planar failure. It is noteworthy that the orientation of J<sub>3</sub> obtained using LiDAR 3DPC is very similar to that derived from GPR results for the main earth fissure affecting the buildings (Fig. 8b).

**Fig. 9** **a** Location of the discontinuity sets J1, J2 and J3 affecting unit T<sub>2</sub> semi-automatically derived from LiDAR 3DPCs. *Dashed line* maps the contact between the massive gypsum (T<sub>2</sub>) and the marl and clay (T<sub>1</sub>) subunits and *dotted line* delineates the rock block fallen between June 2013 and July 2014. Pictures were taken on June 2013. **b** Stereoplot representing the poles and great circles of the discontinuities derived from the 3DPC and the zones of the great circles representing the earth fissure recognized by GPR and the slope. *Black* (J1-1, J2-1 and J3-1) and *green* (J1-2 and J2-2) poles were derived from the 2011 and 2012 scans, respectively

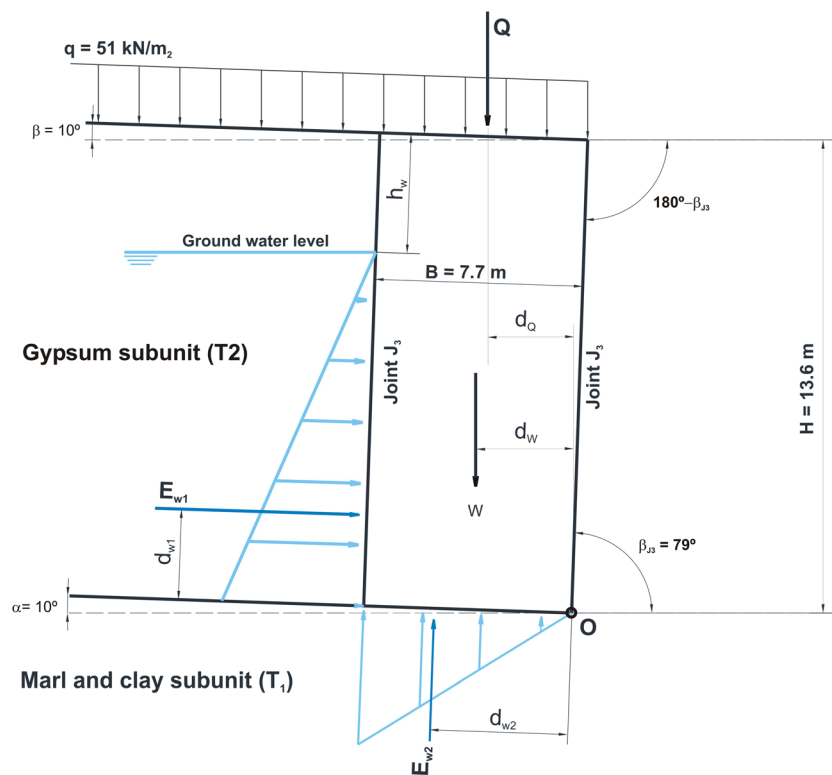
**Fig. 12** Geometry and forces considered for the stability analysis of the rock slope

Toppling model considers that the rock block turns around its base (O in Fig. 12) and the SF is calculated as
